NAVAL SHIP RESEARCH AND DEVELOPMENT CENTER

SUMMARY REPORT ON 1971 ARCTIC TRIALS OF A 10-TON SURFACE EFFECT VEHICLE

May 1973

Report 4100

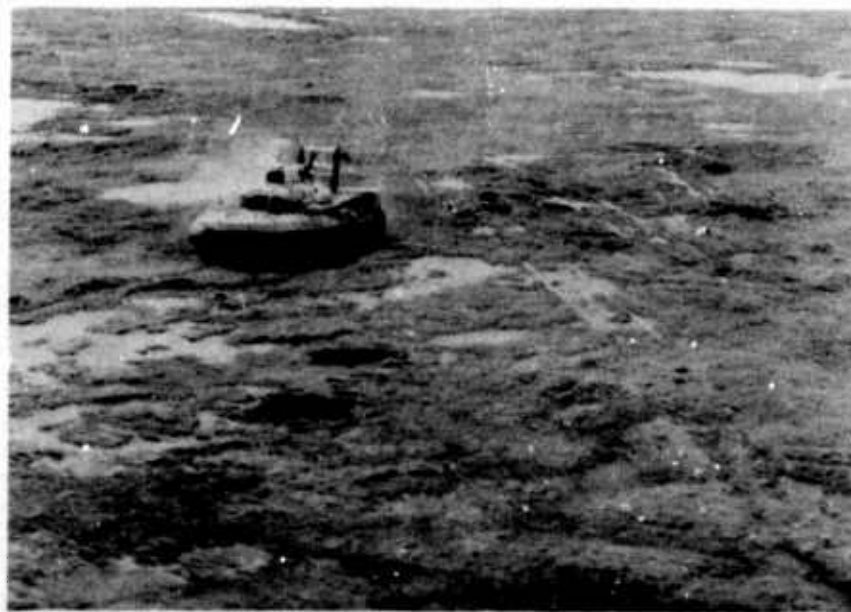
Figure 10 – Test Craft Operating on Tundra

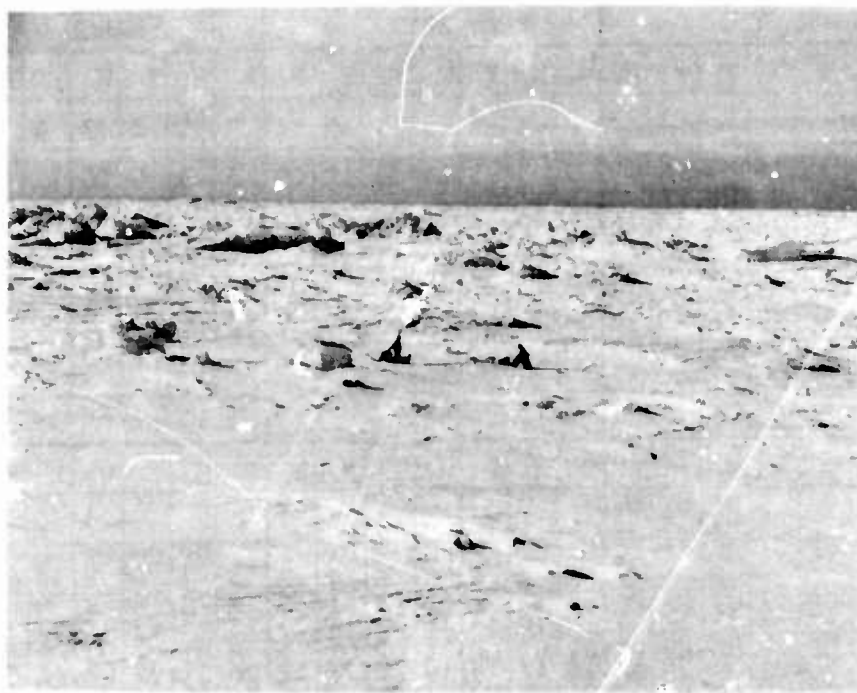
Figure 15 – Typical Pressure Ridges off the Coast
at Barrow

Pressure ridges adjacent to the water-land interface around the Point Barrow area were the most severe obstacles encountered by the test craft.⁶ Figure 15 gives an idea of the range of heights found in a typical pressure ridge. Enroute to and from the test area at Elson Lagoon the craft usually maneuvered through the fringe areas where an occasional piece of ice protruded (3 to 5 ft heights). When required, the test craft operator was usually successful in finding low sections that could be crossed.

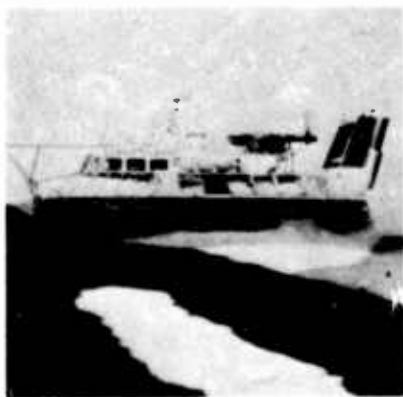
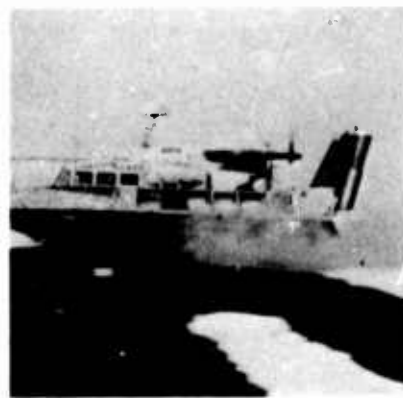
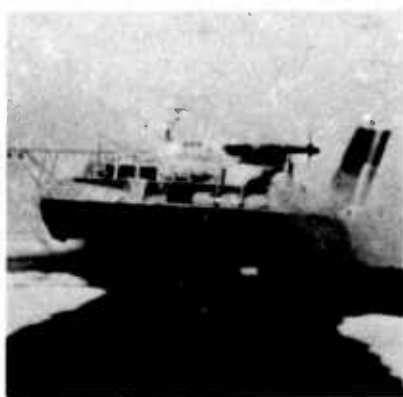
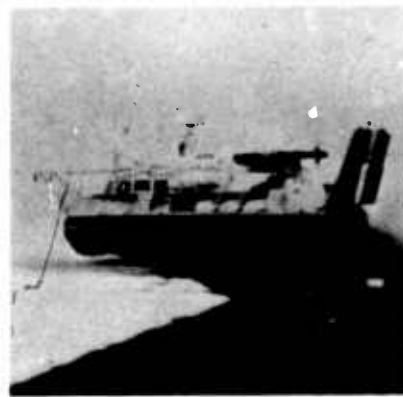
Figure 29 — Pictorial Sequence as Test Craft Crossed Natural Obstacle

As the craft crossed obstacles, the fingers attached to the peripheral skirts dragged across the obstacle and caused considerable damage as evidenced by the debris remaining in the area after each crossing. In addition, the fingers developed an overturning moment which caused the obstacle to rotate and in some cases strike the hard bottom structure of the craft (see Figures 27 and 28). Figure 29 shows the craft crossing a natural obstacle (gravel bank) at Barrow; again, the fingers dragged across the obstacle and eroded the bank.

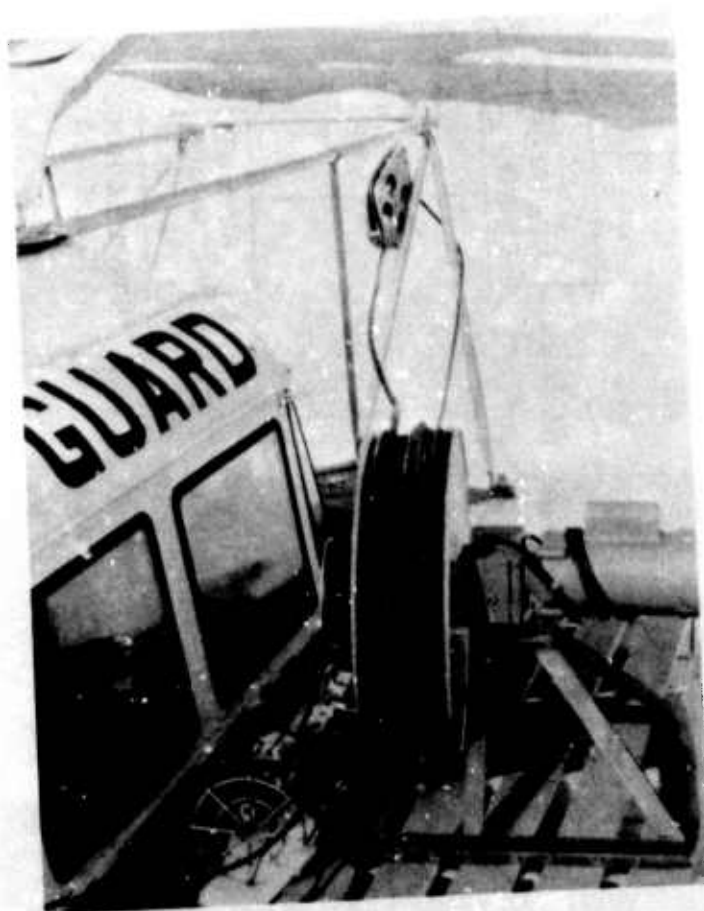
Figure 58 — Data Acquisition System for 1971
Marginal Ice Zone Studies

In support of an ARPA-funded effort at the Arctic Submarine Laboratory (NURDL) San Diego, California, the University of Washington is conducting studies of the oceanographic and acoustic characteristics associated with the Arctic marginal ice zone (MIZ). The purpose of the test reported here was to demonstrate the ability of an SEV to serve as a mobile data-gathering platform in support of the MIZ studies. For this demonstration, the data acquisition system was removed from the SEV, and a portable salinity-temperature-depth data acquisition system was installed in its place (Figure 58).

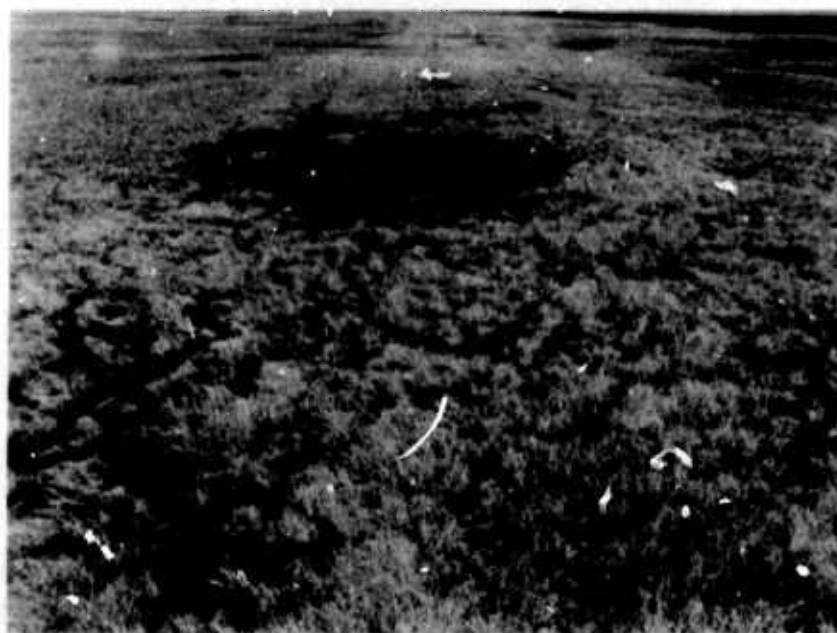
Figure 63a - Site 1, Lane 3, after 25 Passes
at High Speed

Figure 63b - Site 1, Lane 4, after 25 SEV
Passes at Low Speed

Figure 63 - Effect of Vehicle Speed on Terrain Degradation

Figure 63 indicates the effect of vehicle speed; the more gentle drag of the skirts at low speed caused considerably less degradation to the tundra surface. Of course color adds a dimension to photography that is lacking in black and white; see Abele.³¹

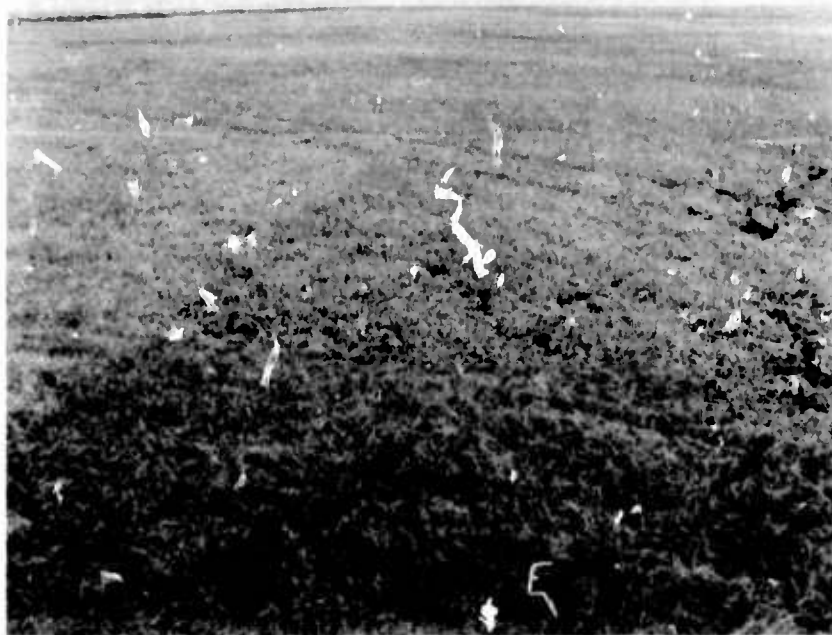
Figure 64a – Site 1, Lane 6, after 10 Minutes of Hovering (No Skirt Drag)

The relatively insignificant effect of the air flow alone (skirt drag not present) is illustrated in Figure 64a. There was no recognizable signature from 10 min of hovering, but one SEV pass at high speed (a contact time of only a couple of seconds) at any place on the terrain left a visible trail (Figure 64b). This relative long-range effects will become apparent only after future monitoring and annual inspection of the test lanes; whether one pass is more or less severe than 10 minutes of hovering cannot be evaluated now. It is quite apparent, however, that 25 passes, and certainly 50 passes, have a more severe effect than prolonged hovering for these cushion and skirt characteristics.

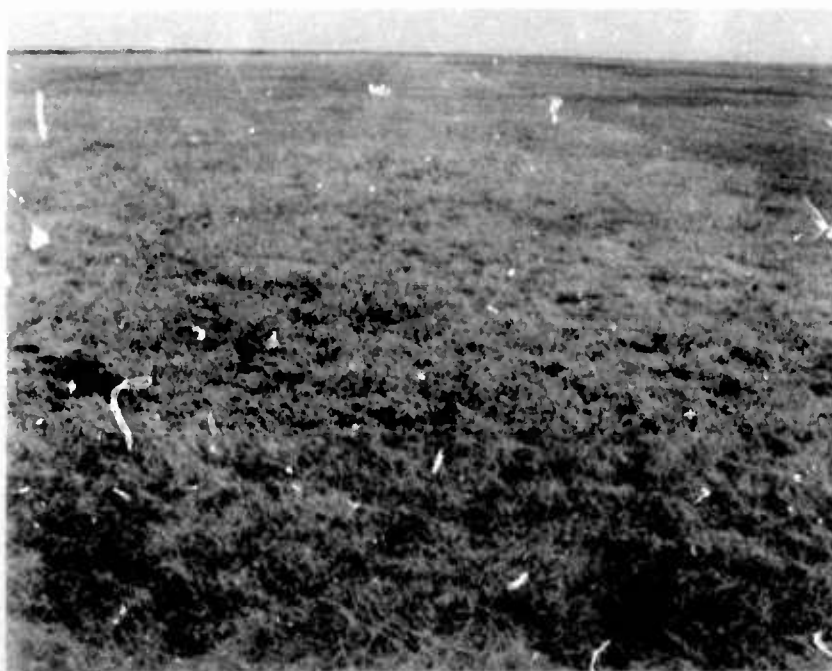
Figure 64b – Site 1, Lane 1, after One SEV Pass at 35 MPH

Figure 64 – Visible Effects on Terrain from 10 Minutes of Hovering and One High-Speed SEV Pass

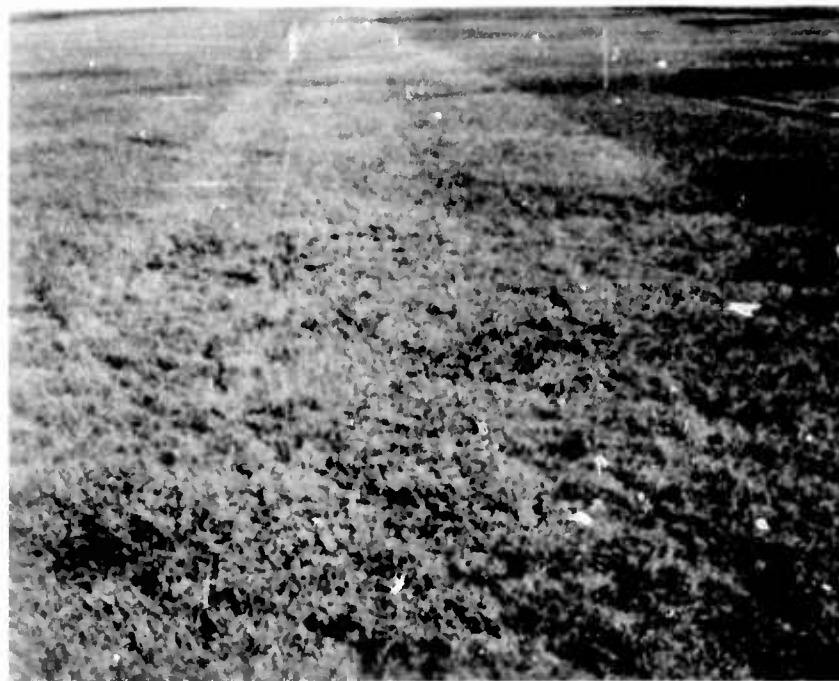
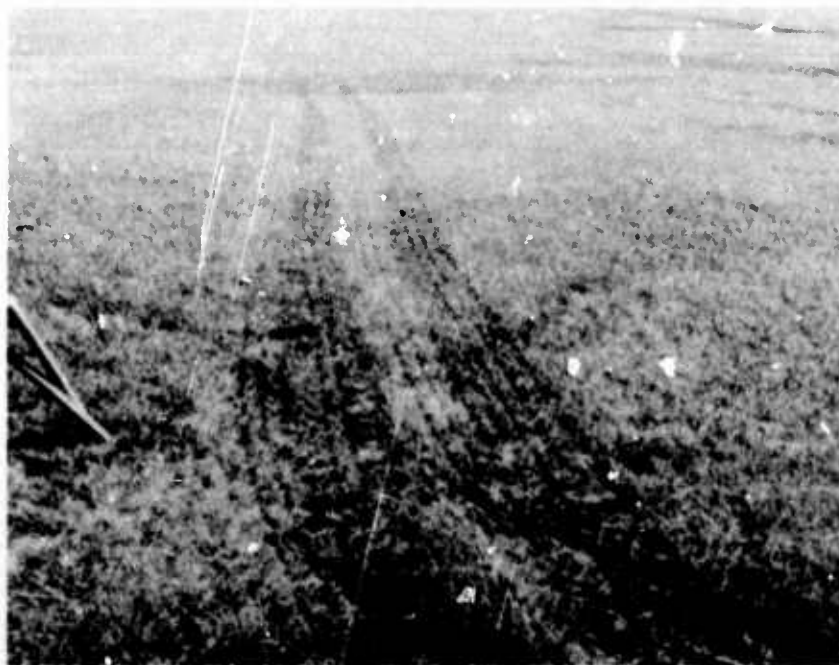
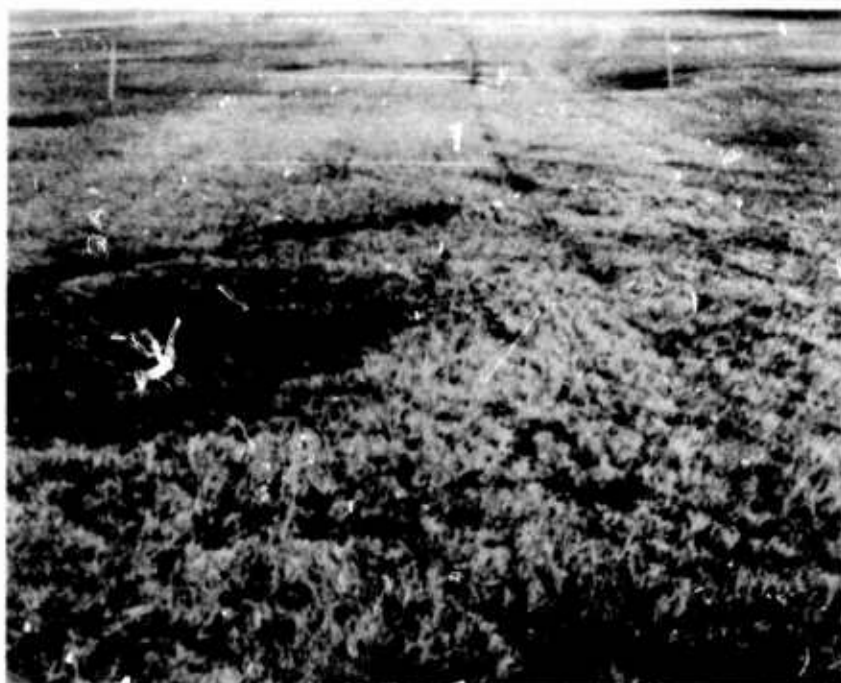
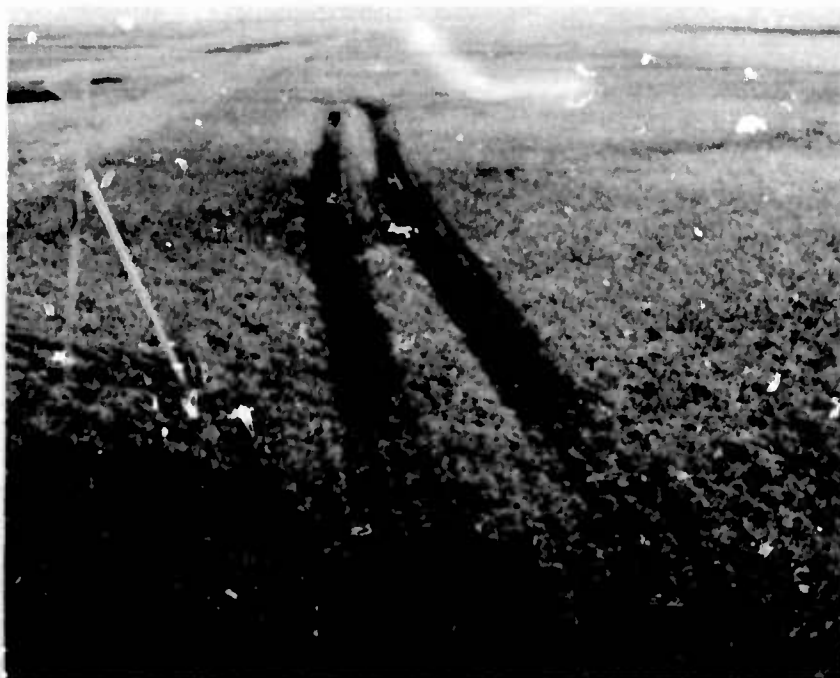
Figure 65a - Site 1 after One Pass with Test Craft

Figure 65b - Site 1 after One Pass with Weasel

Figure 65 - Visible Effects on Terrain from SEV and Weasel Transit

Figure 65c - Site 1 after 25 Passes with Test Craft

Figure 65d - Site 1 after 25 Passes with Weasel

Figure 65 indicates the visible effects of one and 25 passes by the SEV and the Weasel. It could be observed that the extent of damage to the vegetation from skirt contact was not uniform throughout the traveled path; areas with even slightly raised microrelief (a few inches or less) sustained more severe degradation than flat, smooth areas.
